THE MALDEN SURVEY

A REPORT ON THE CHURCH PLANTS OF
A TYPICAL CITY, SHOWING THE USE
OF THE INTERCHURCH WORLD MOVE-
MENT SCORE CARD AND STANDARDS
FOR RATING CITY CHURCH PLANTS

Compiled Under the Direction of
WALTER SCOTT ATHEARN

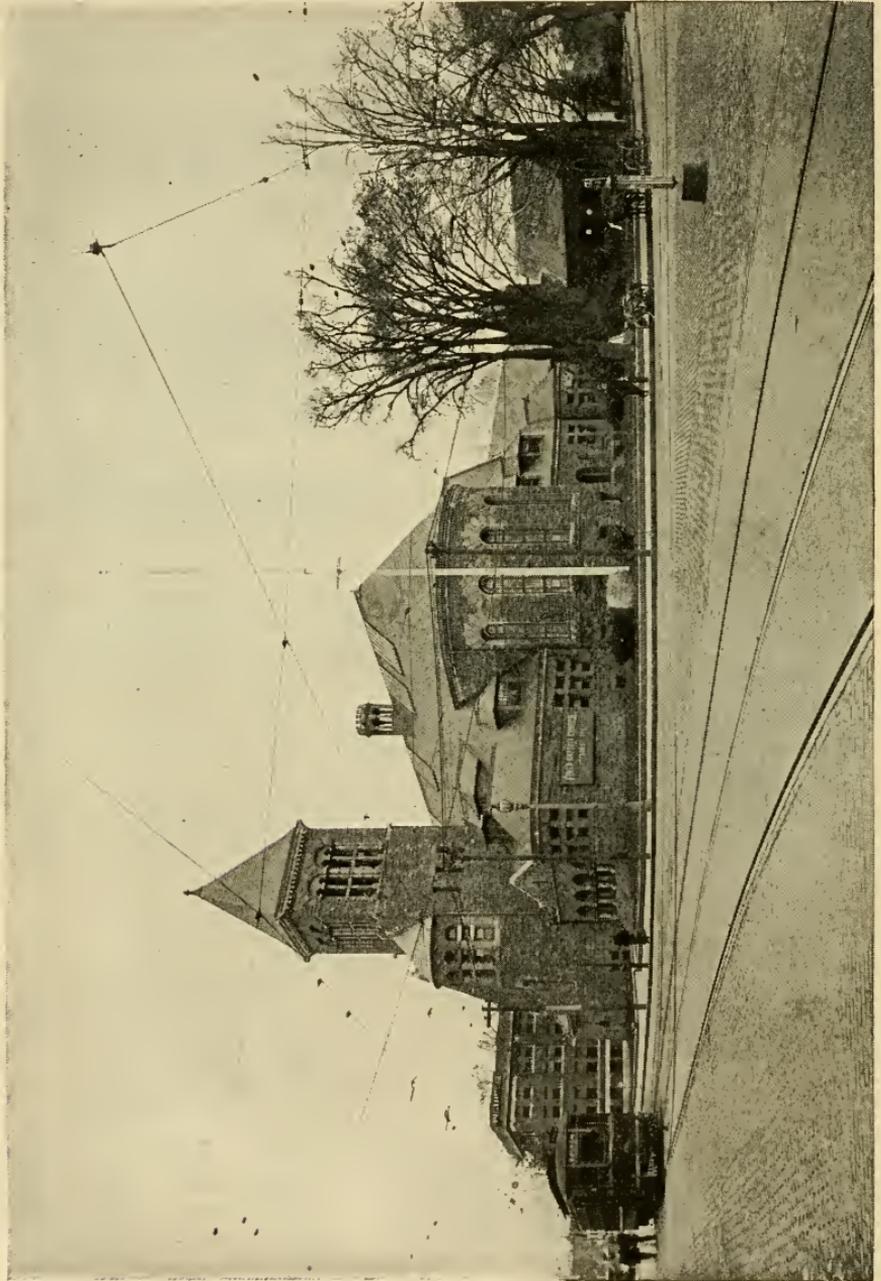
ILLUSTRATION I. FIRST BAPTIST CHURCH

The score allotted to this church and religious education plant indicates that in many ways it conforms to the standards developed for an ideal plant. The buildings are located at the intersection of two of the main streets of the city and in close proximity to other community buildings such as the public library and the public high school. The buildings would make an attractive addition to any community.

The outstanding features of this plant are the well-planned auditorium, the satisfactory service systems, the large number of high grade and separate classrooms and the exceptionally well-equipped kitchen. The limitations of the site, the unsatisfactory natural lighting of some of the rooms, and the omission of certain community service rooms included in the score card have placed this building in the 700-800 point group. Because the main church is a reconstructed building with the limitations which that puts upon room arrangement and the like, the First Baptist does not receive the perfect score on a number of items. It is the loss of the few points on many items which reduces the total score, and not the failure to provide accommodation for all forms of service.

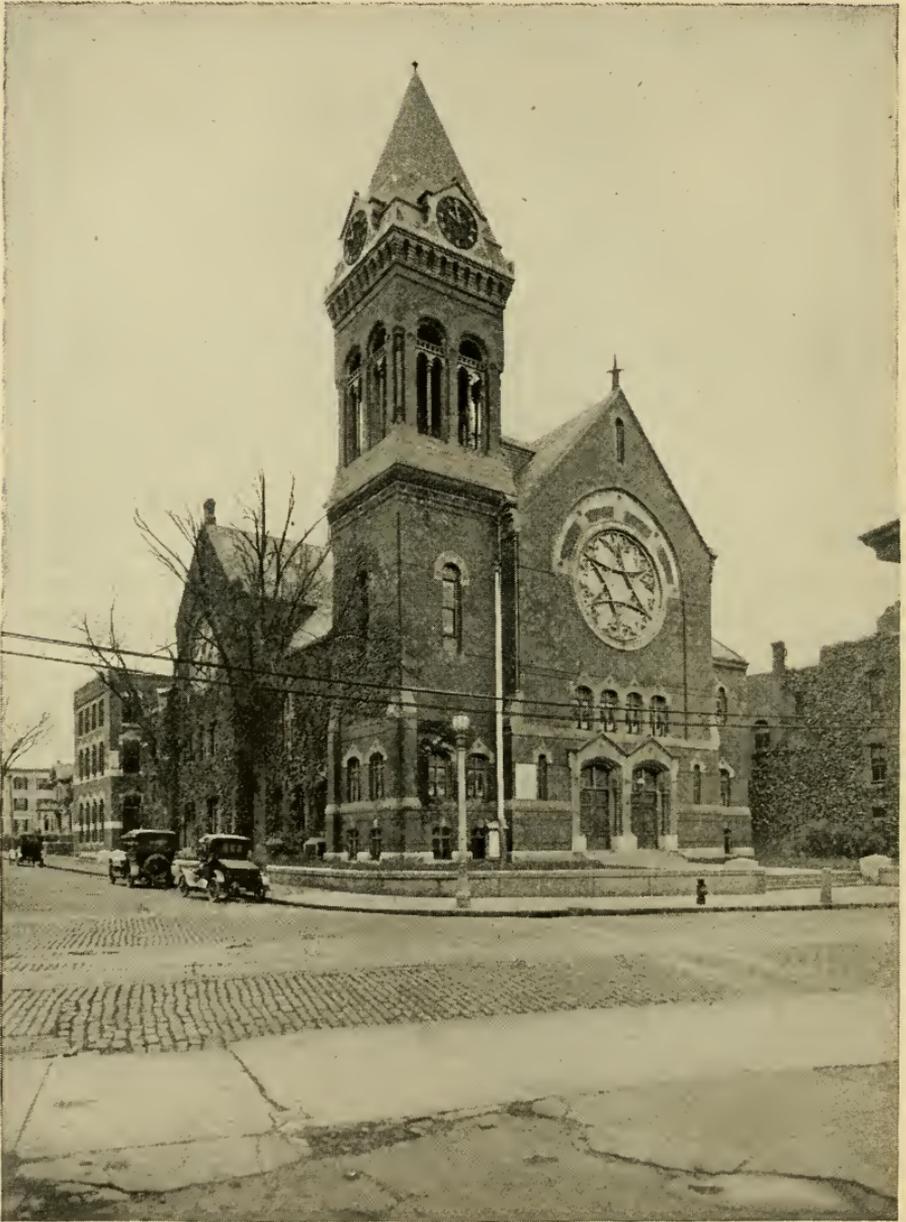
ILLUSTRATION 2. CENTRE METHODIST CHURCH

The emphasis placed by this church upon a high-grade church auditorium with its desirable equipment and upon a religious school equipment which permits of the segregation of many classes is evidenced in the detail score given these items. The building is located on a corner site with non-fireproof business houses in the immediate neighborhood. The size of the site has necessitated building upward. This has produced a second story auditorium and a three story school building, which should be allowed only in highly fire resistive construction. No out-of-door activities are possible on this site. The location of this downtown church opens great possibilities for community service which cannot be adequately met by the limited existing provisions. The vacuum cleaning and elevator service installations are striking features of this plant.

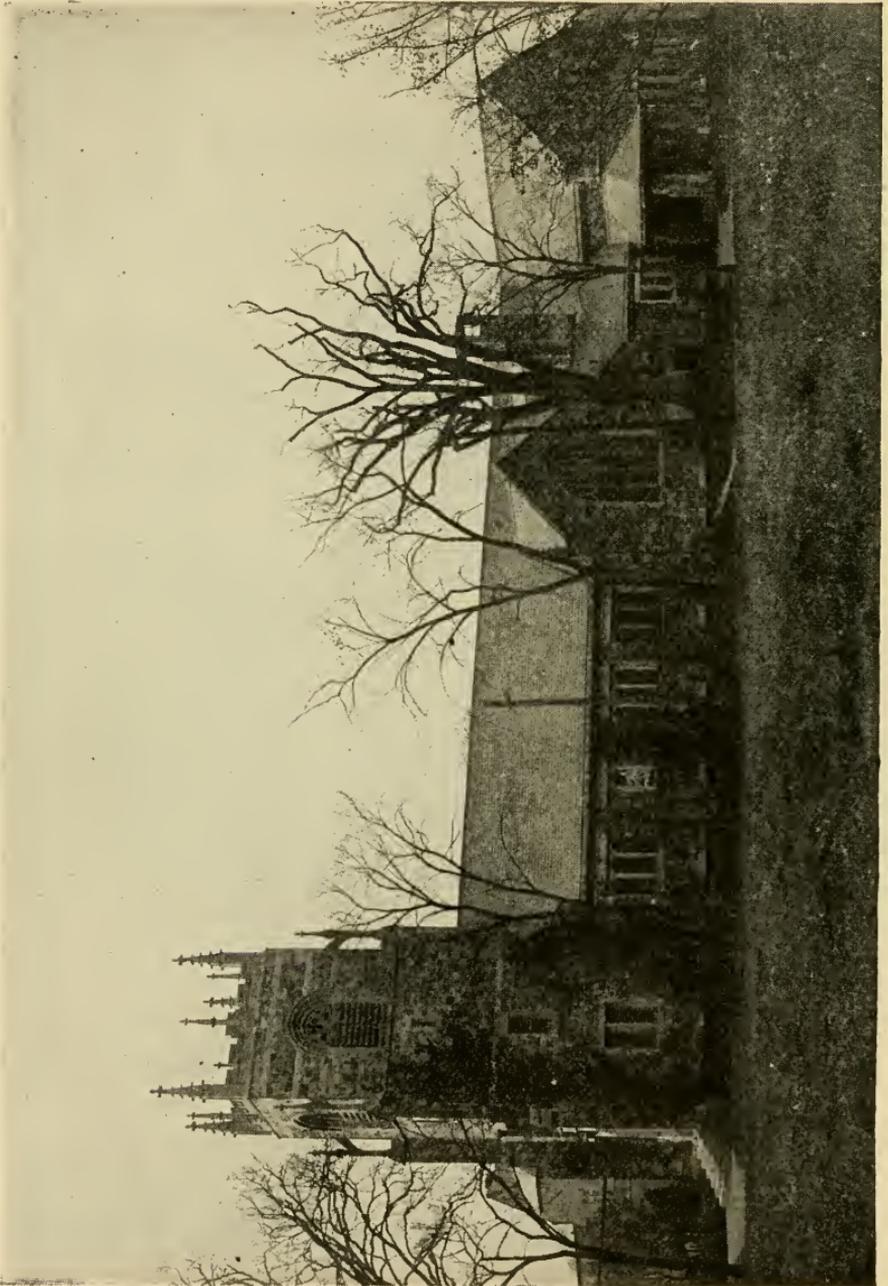
ILLUSTRATION 3. FIRST PARISH IN MALDEN, UNIVERSALIST CHURCH

Conspicuously and pleasingly located on an intersection of streets the First Parish in Malden, Universalist, is one of the most striking and attractive churches in Malden. It is unfortunate from the standpoint of the service which this church should render that so picturesque an exterior should be handicapped by an interior equipment and arrangement inadequate in many respects. A beautiful auditorium is partially spoiled by insufficient light, the corridors are narrow and poorly arranged, the stairways are winding and inadequate, the classrooms are too few in number, poorly lighted and poorly equipped; the service systems are in many cases inadequate, while the element of fire protection has received very little consideration, either in the basement where the furnace is located, or in the ease with which large numbers can get from one part of the building to another. The church has made commendable provision for some forms of special service neglected in many of the other churches in Malden, even though these do not meet the standards set by the score card. Some of these are the pastor's study, recreation room, auditorium with stage, and dining room and kitchen. The convenience of the rooms and the service of the church could be materially increased if several of the rooms were rearranged with this in mind.

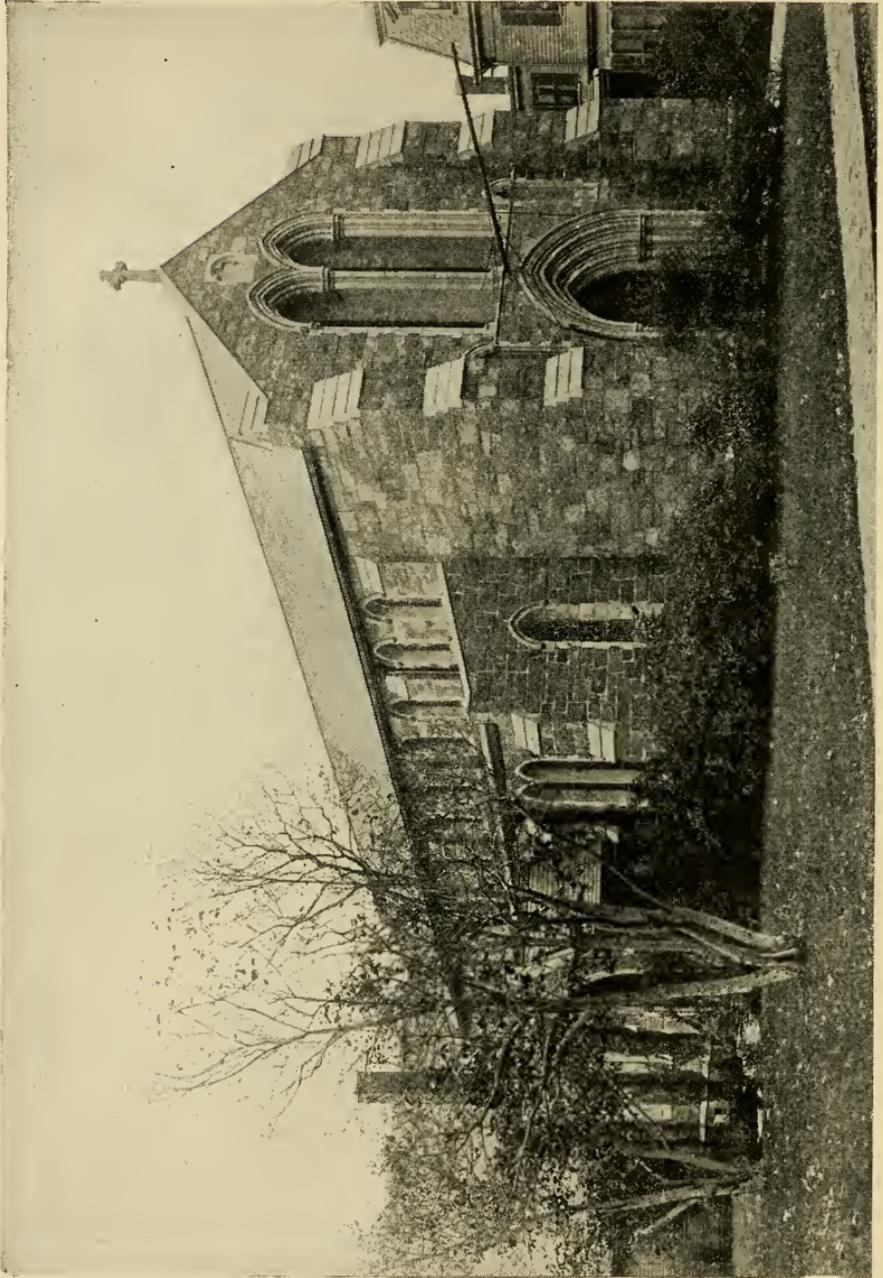
ILLUSTRATION 4. ST. PAUL'S EPISCOPAL CHURCH

If the high standard set in the construction of the new church auditorium section of this plant had prevailed throughout, the score allotted would have been very much higher. This new section accounts for the 112 points on church rooms and for much of the score on Item II. It is hoped that, when the old sections of this plant are replaced by new buildings, the standards of this score card will be used as a guide. There will be a distinct need for additional land if the desirable standards are reached. It has already been recognized by the members of St. Paul's Church that the present school and community provisions are totally inadequate.

The attractive elements in the present situation are the harmonious relationship between the landscape and the new building and the ease of entrance and exit to the new building.

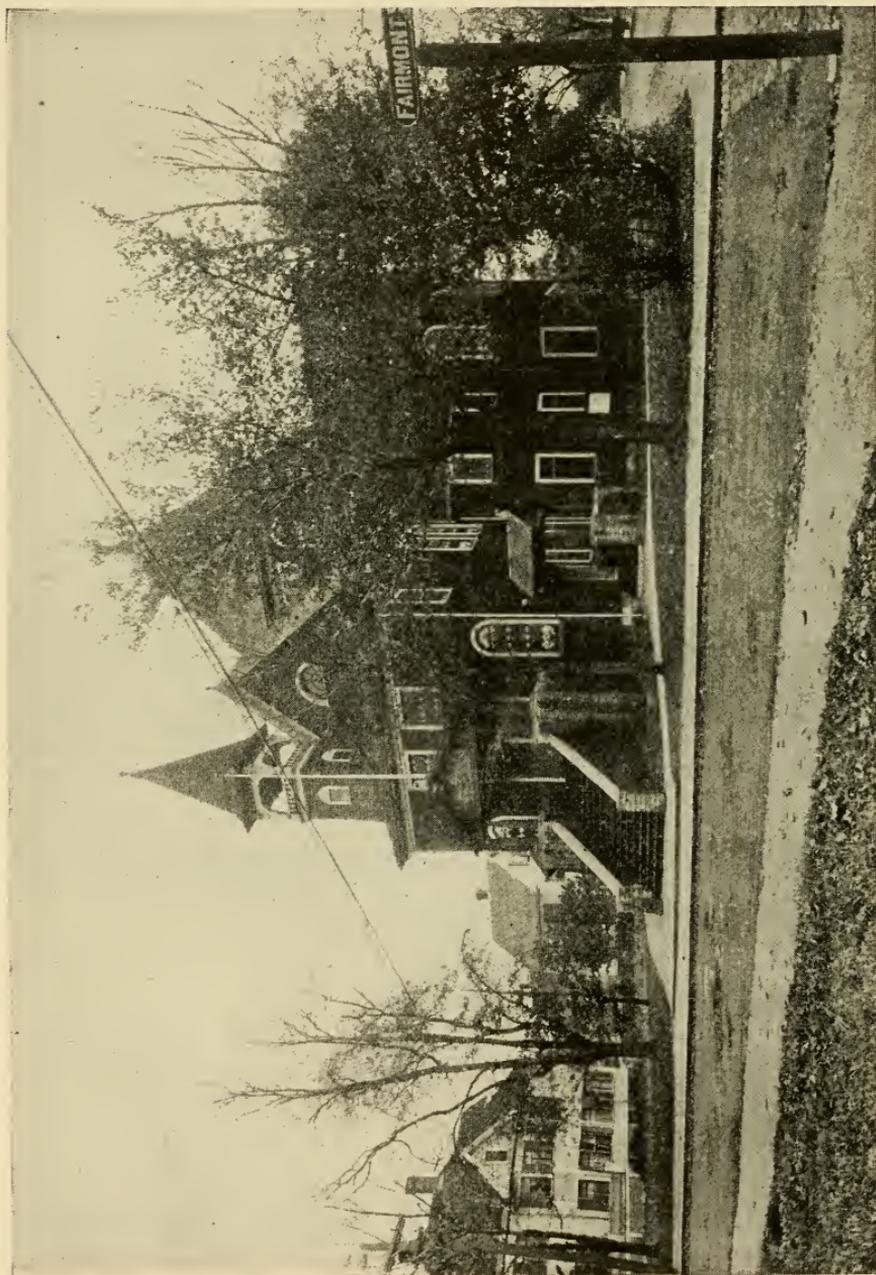
ILLUSTRATION 5. ROBINSON METHODIST CHURCH

The church is unfortunate in its main entrance and in its second story auditorium. The present structure is the result of an addition to an older building. A better plan would have involved discarding the old structure, increasing the size of the site and building a fire-resistive structure which embodied the standards set up by modern needs.

Attractive elements in this situation are the library and the homelike tendency in the rooms of the first floor.

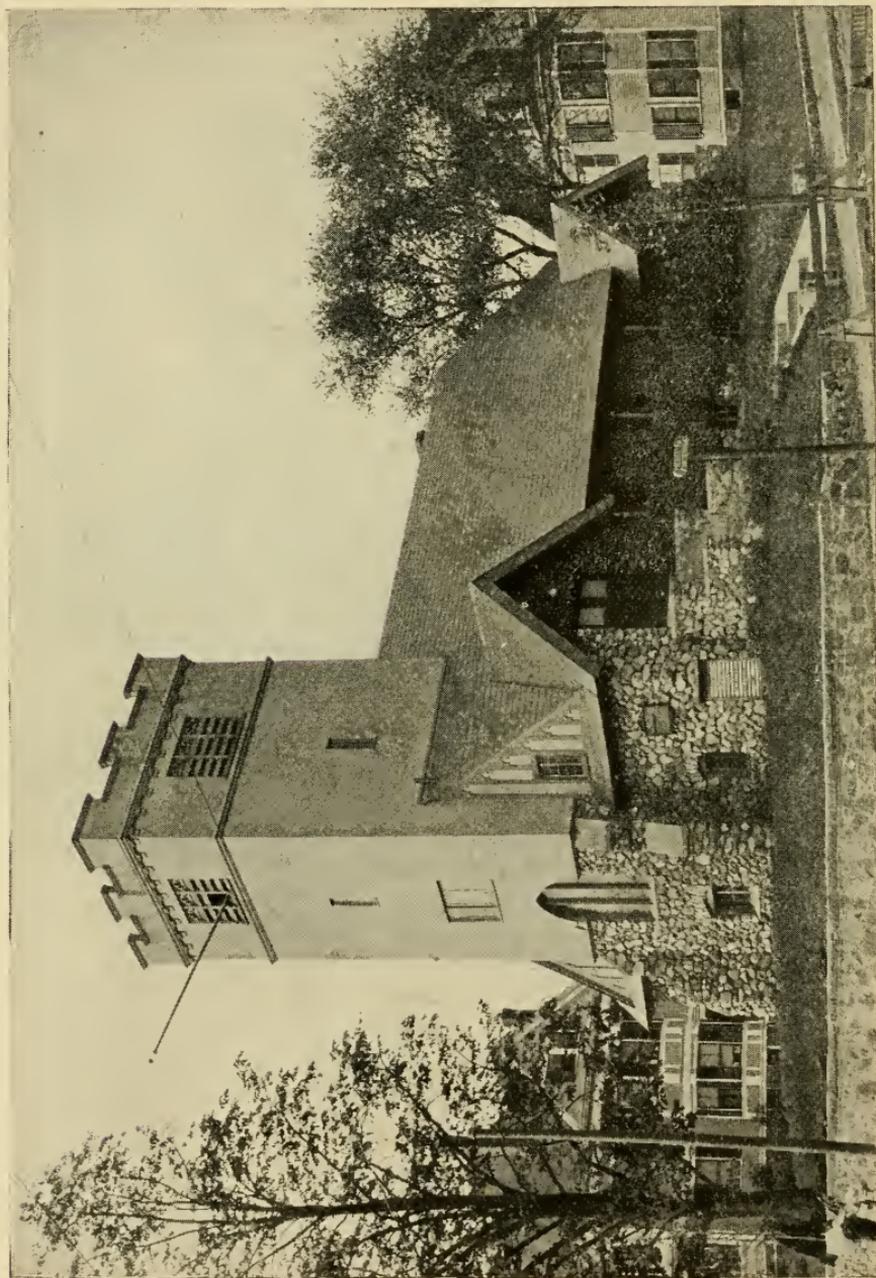
ILLUSTRATION 6. FAULKNER METHODIST CHURCH

This church presents an attractive exterior. Although its construction is recent as compared with that of many of the other Malden plants, there is little evidence of planning for the future in its site, the plan of the building or its equipment.

The site, although much more satisfactory than others, will never suffice for a large community plant, the need for which will arise in this locality. The building lacks to a large degree desirable educational and community service provisions. The attractive elements in the case are the artificial lighting of the auditorium and the pleasing exterior. Little else about the building commends itself for mention.

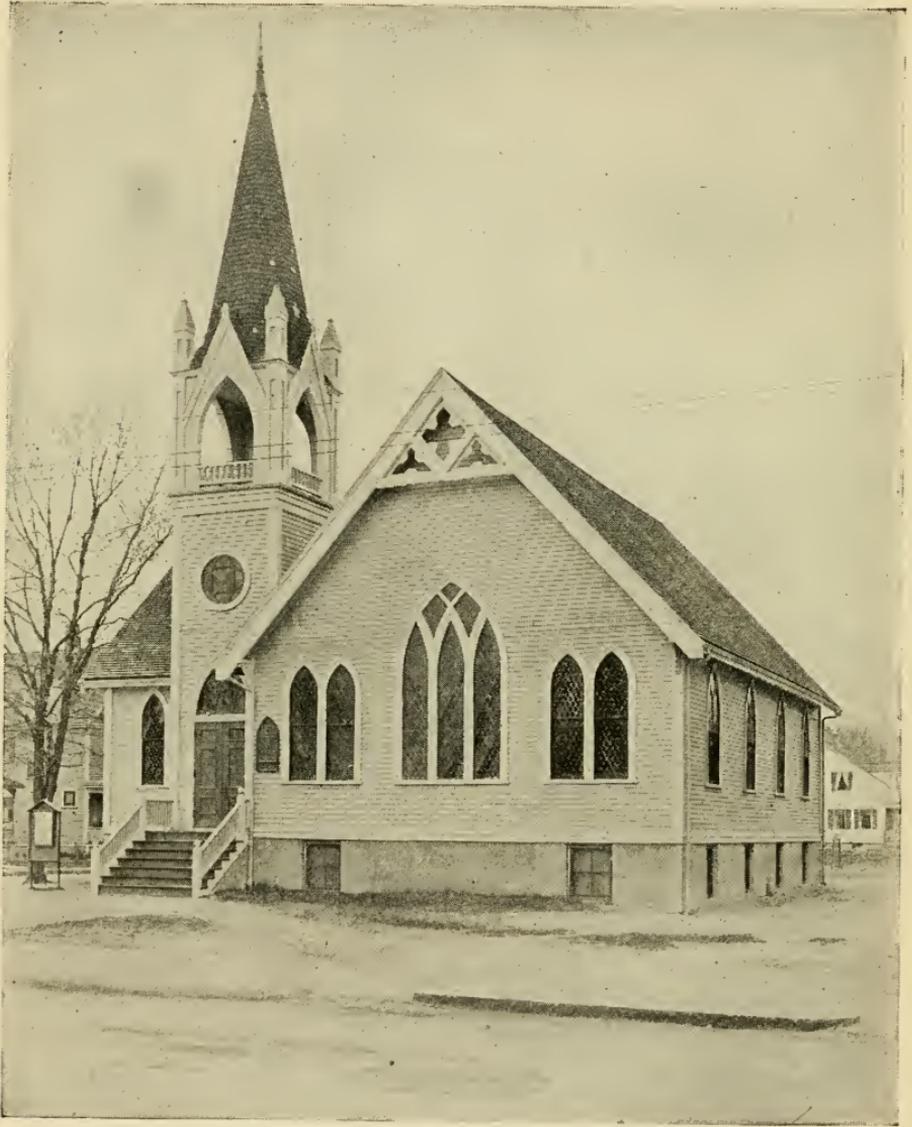
ILLUSTRATION 7. LINDEN METHODIST CHURCH

This building was scrupulously clean throughout. Its equipment was simple, yet well cared for. Its ornamentation was inexpensive yet attractive and gave evidence of much thought.

No doubt, although the site is small, the service systems limited, and auxiliary rooms few in number, the plant is, in many respects, efficiently serving its patrons.

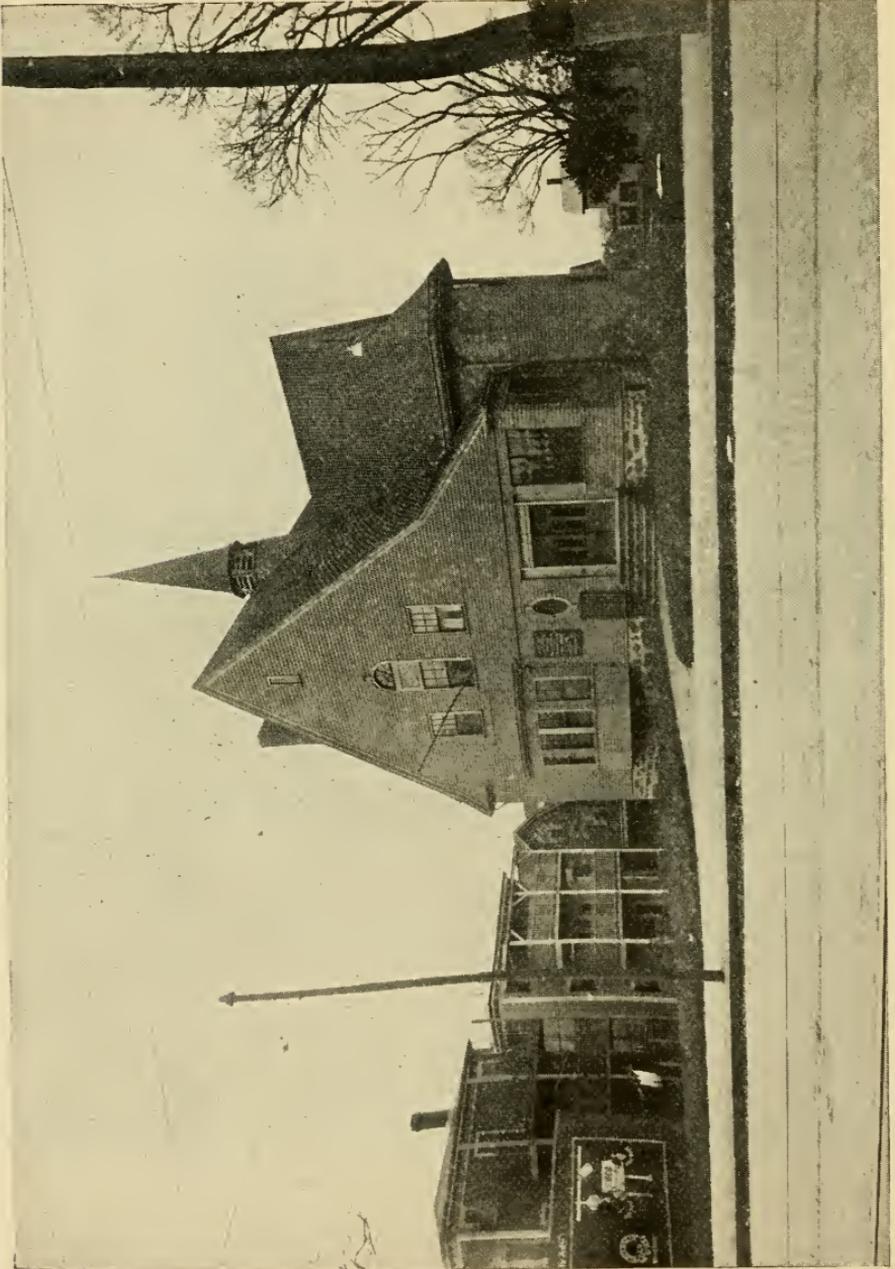
ILLUSTRATION 8. MYSTIC SIDE CONGREGATIONAL CHURCH

This church falls in the 350-400 point group. The outstanding features of the plant are the relatively large site, the attractive front classroom and the businesslike pastor's study.

The congregation has outgrown this plant and has already planned to build a new structure. It is hoped that the faults of the old building will be eliminated in the new. In this building the fire danger is ever present, the kitchen facilities are very poor, the toilets fail to reach a satisfactory standard, storerooms are inadequate, the lighting system is defective, the kindergarten room unfortunately placed and many desirable features are lacking entirely.

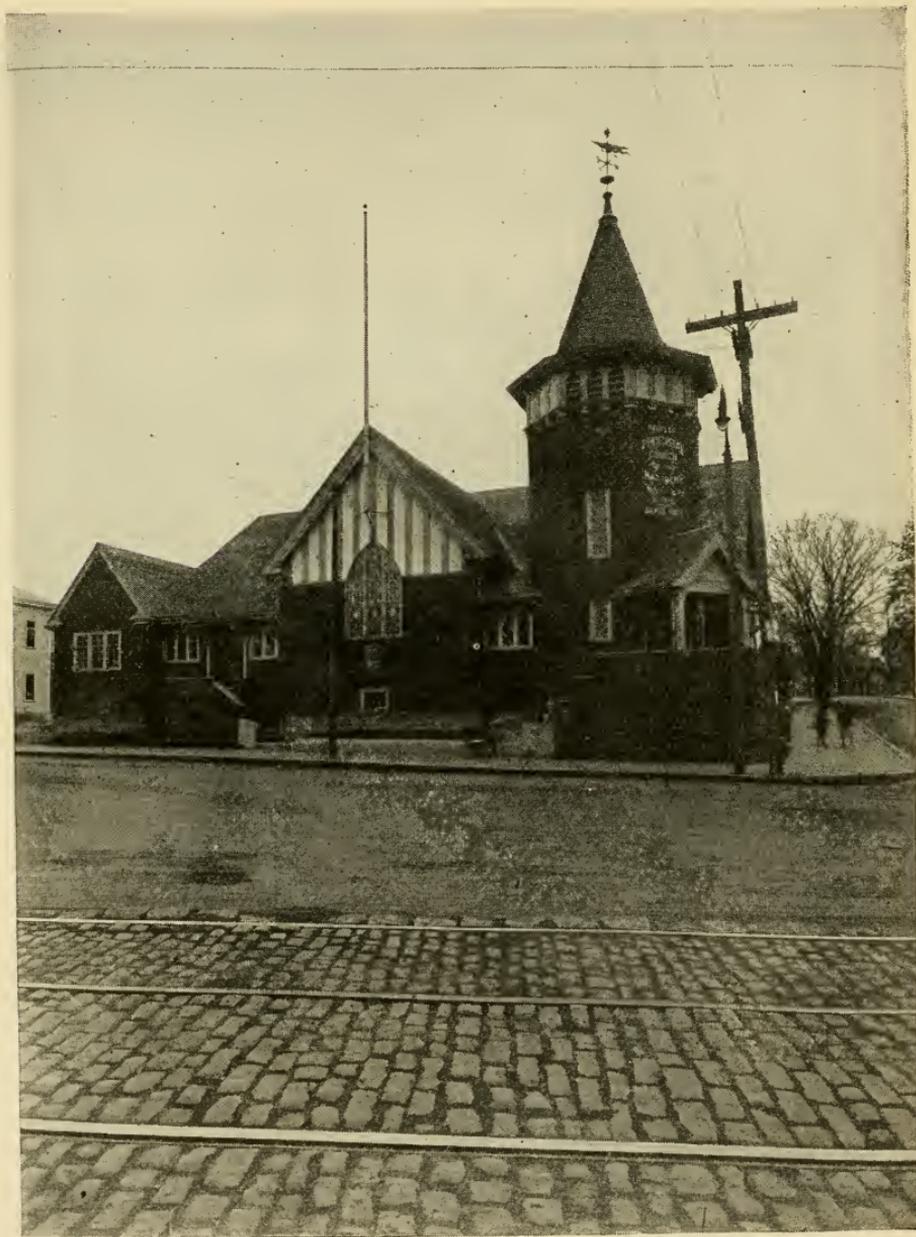
ILLUSTRATION 9. PEOPLE'S PENTECOSTAL CHURCH OF THE NAZARENE

This church is well located on a corner lot and so orientated as to command the best possible lighting. It is a relatively new structure but of a construction more typical of residences than of churches. The site is so small that the church almost stands on the sidewalk. The interior of the church is very attractive, with plain walls, well-harmonized woodwork, artistic and efficient indirect lights and new and well-kept furniture. The general effect is somewhat spoiled by some large water stains on the walls resulting from leaks, which in turn were results of light construction. The basement is very small, extremely low and entirely exposed to fire risks from the furnaces. The provision for religious education rooms is convenient as an enlargement of the auditorium, but neither well-arranged nor adequate for graded instruction. The fact that the pastor's home is attached to the church makes it possible for him to be directly in touch with the work of the church. The score of this church is lower than it otherwise would be because of the entire absence of all rooms for community service—a provision which the church does not believe in making.

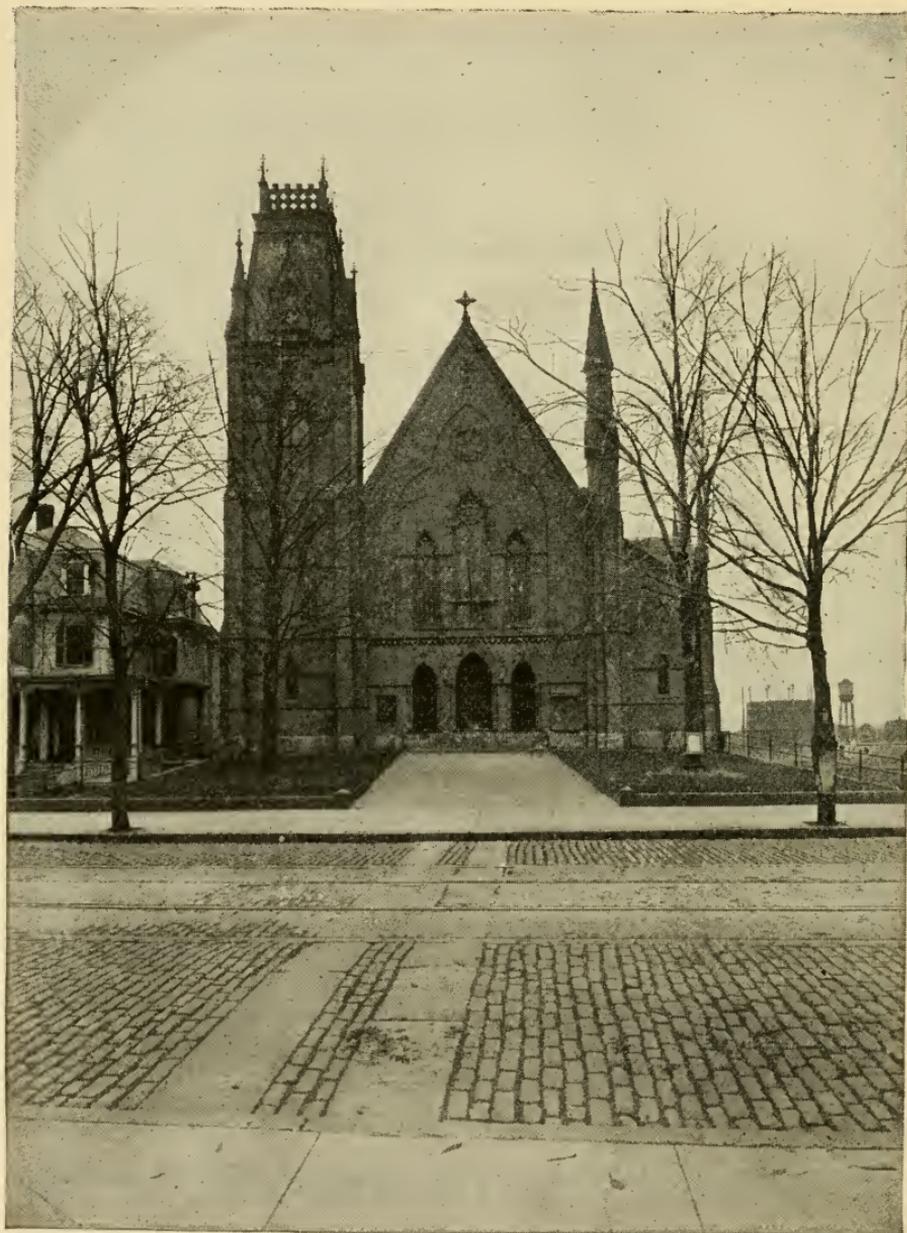
ILLUSTRATION 10. FIRST TRINITARIAN CONGREGATIONAL CHURCH

Constructed long before the extensive community service suggested by the score card standards was required of churches, this plant is found deficient in many particulars. The maintenance of this building has been high-grade with the exception of the basement. Its location was at one time much more desirable than today. The environment indicates that the church is gradually being crowded out by industrial and commercial developments.

The largest number of points has been allotted this building in its church rooms, especially its auditorium. The almost total lack of classrooms, the limitations of the community service rooms and its non-standard service systems account for much of the low score.

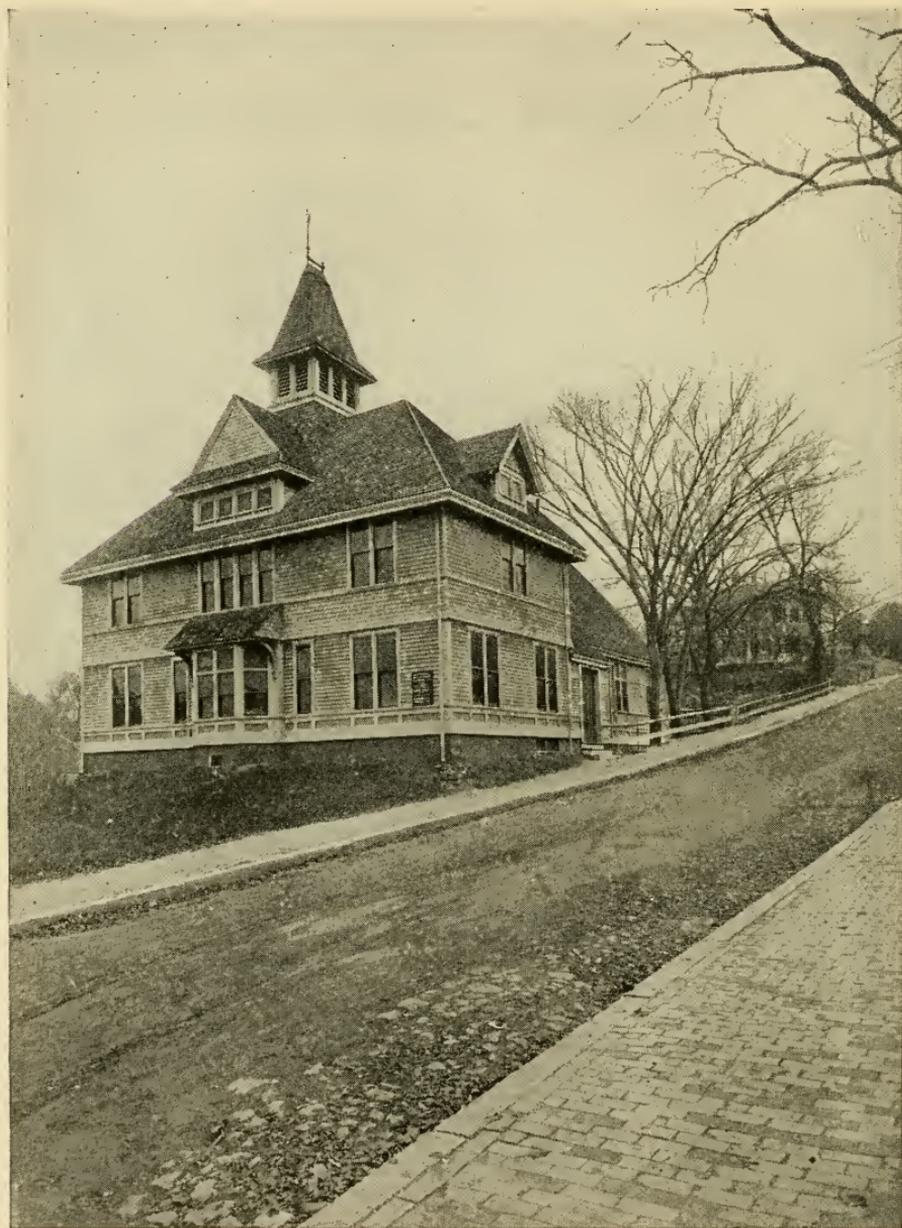
ILLUSTRATION 11. EASTERN AVENUE BAPTIST CHURCH

This church has little to recommend it to the passerby. Its site is undesirable and the building in many ways does not even resemble a church. Its interior, however, is commendable in many respects, which accounts for its receiving a higher score than would appear warranted from an outside view. The building is scrupulously clean even to the basement, the decoration of walls and ceiling is recent, harmonious and attractive and the service systems, while far from standard, are efficient and in a good state of upkeep. The congregation has given most of its attention to the efficiency of its church rooms which receive a relatively high score. In addition to the main auditorium, provision has also been made for a small assembly room which can also serve for church board meetings, for a special room equipped for communion services, for a pastor's study and for a church office.

When the plans that are now being discussed for finishing the basement and making adequate provision for preparation rooms for baptismal ceremonies are made actualities, this church will find its opportunities much increased and will be approaching a maximum use of a poor building.

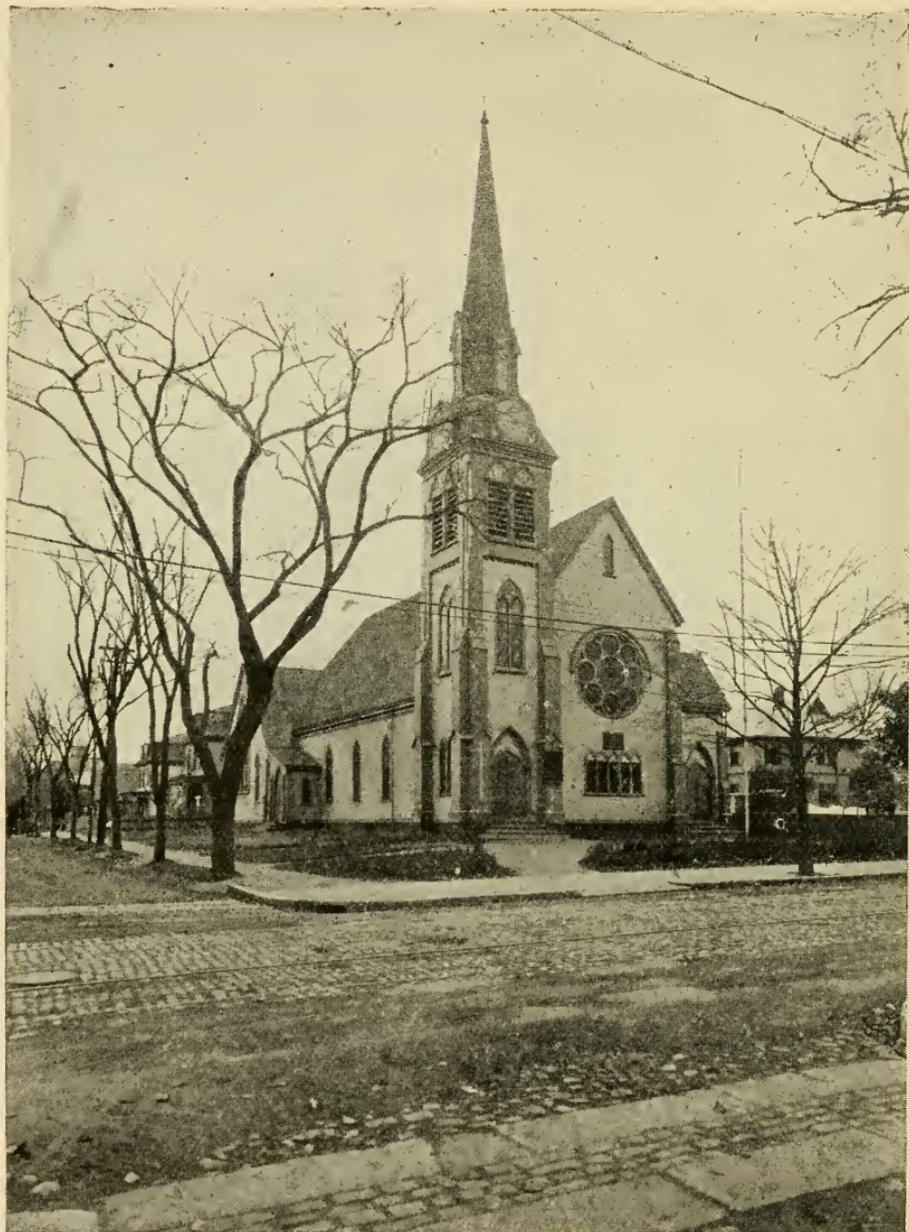
ILLUSTRATION 12. MAPLEWOOD BAPTIST CHURCH

The total score allotted this church is practically the same as that for the Eastern Avenue Baptist, although the exterior views would not show them equal. The Maplewood Baptist is a distinctly church-like frame structure but there is little to commend in its internal structure. The building has not been recently redecorated, and little attention has been paid to general esthetic effect. The building is a fire-trap from the rubbish-strewn, ash-filled basement to the paper-filled closet under the roof. The service systems are old, insufficient and poorly installed, particularly the heating, lighting, and toilet systems. The religious school rooms are too few, poorly arranged, and equipped with old and uncomfortable furniture.

The church is used for some community activities now, though its equipment for this form of service is very inadequate and in a discouragingly poor condition. A church library is provided though it has the appearance of being seldom used. It would be possible greatly to increase the community service of this present plant, although no amount of remodelling would make it approach the standards for the various items.

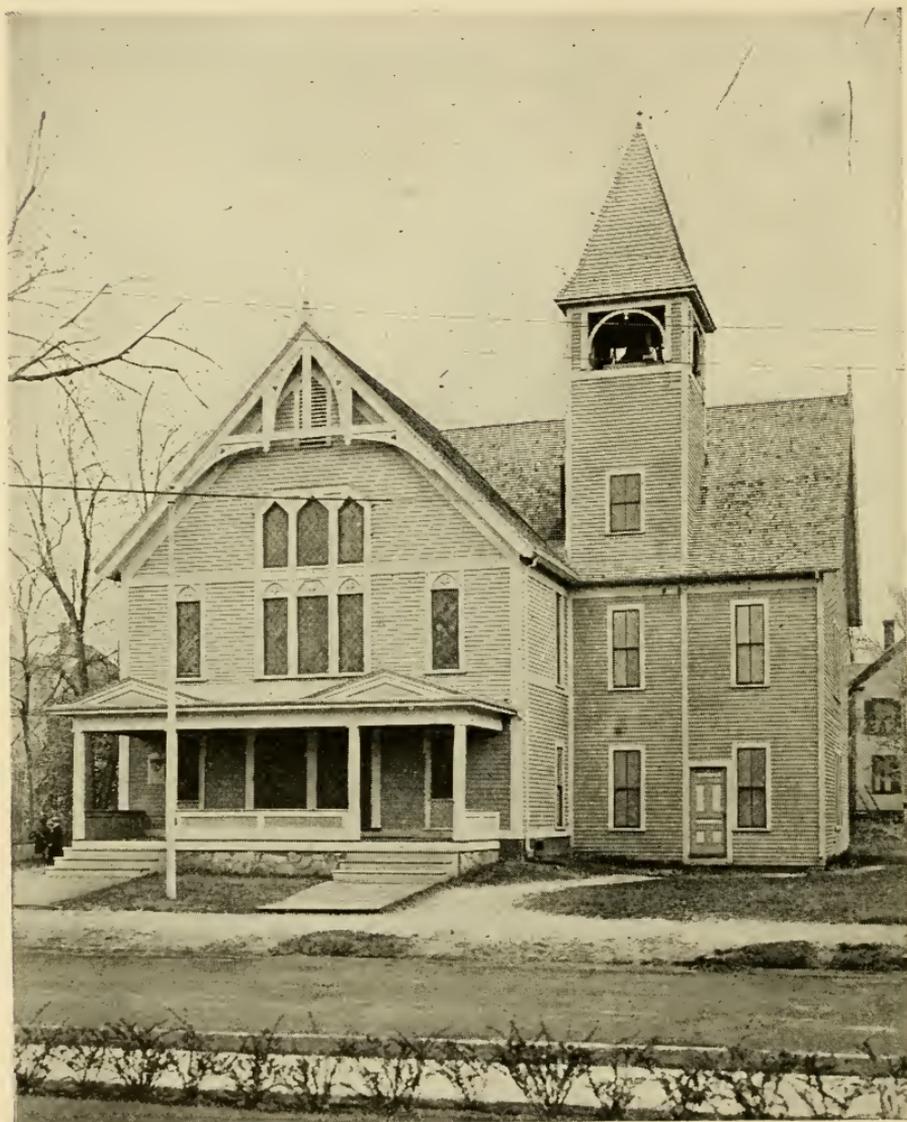
ILLUSTRATION 13. LINDEN CONGREGATIONAL CHURCH

The Linden Congregational Church was allotted about one-third of its possible score. This is due in part to the fact that it is a small church serving a small congregation and seriously limited not only in its equipment but also in the lines of activity it can support. It is possible that much more would be gained if congregations of this size would give up a little of the convenience of easy accessibility and attend a larger community center church which possesses the physical equipment necessary for a richer program of religious instruction, and community service.

The site of this church is too small for anything but the building to stand upon and is also poorly drained. The present building serves as a handicap, not only because of the meager number of rooms available but also because of their poor equipment. The main auditorium being on the second floor with inadequate means of access is a source of both inconvenience and danger, even though it makes possible a first or ground floor without any excavation for a basement.

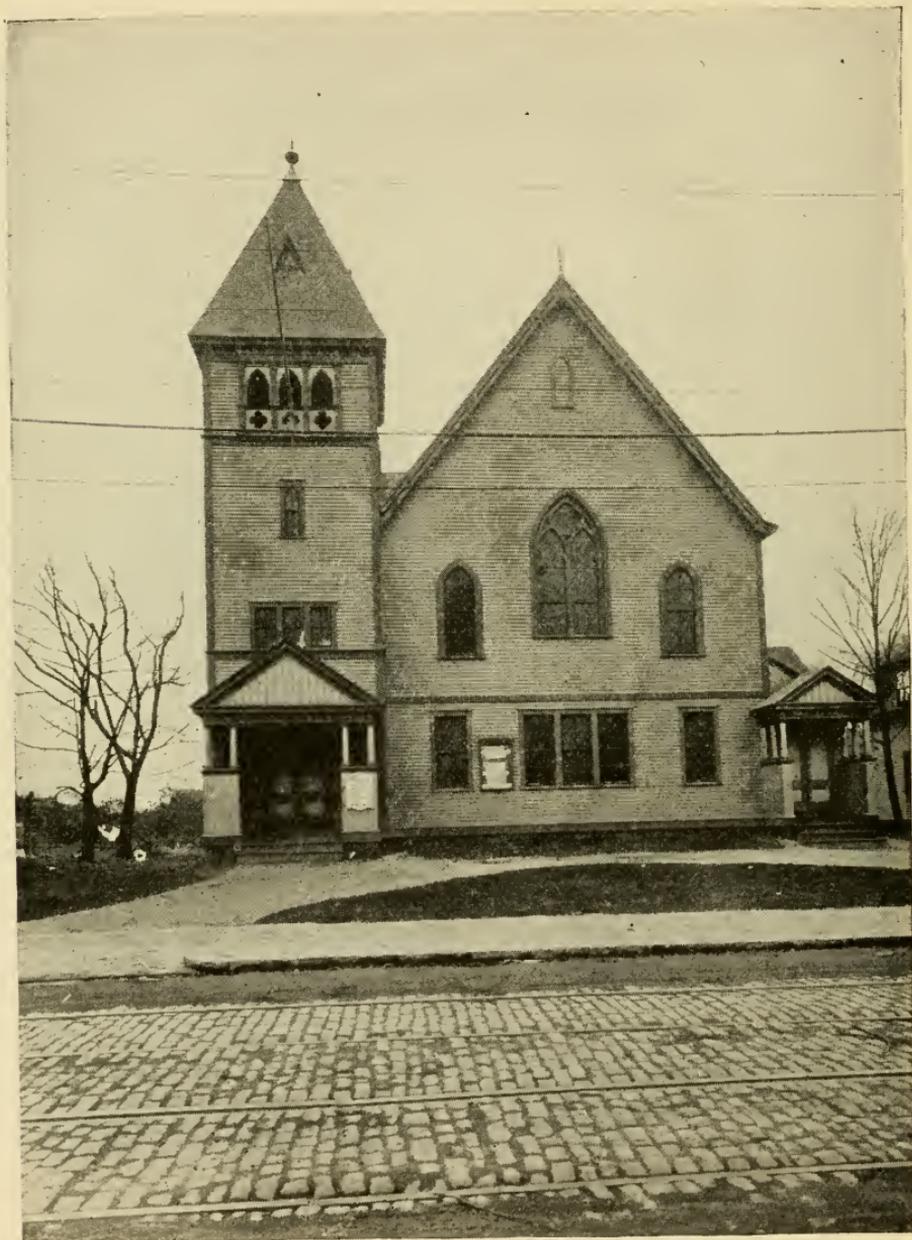
ILLUSTRATION 14. MAPLEWOOD METHODIST CHURCH

This is another church which reaches about one-third of its possible efficiency as shown by its total score. For reasons previously given, probably it would better be abandoned in order that its congregation might join forces with some larger, better equipped church.

The building is old and poorly arranged. The rooms used for religious instruction are well grouped although they are inconvenient of access and poorly furnished. The service systems—heating, lighting, toilet, water supply and fire protection are among the poorest in all of the churches in the city. As in many of the smaller churches, the auditorium is the most commendable room of the church, but this one is made less so by being on the second floor and provided with very inadequate stairways. Almost no effort has been made to do any form of community service other than the traditional, distinctly religious forms. The present church plant would seriously lessen the chances of success for any such program.

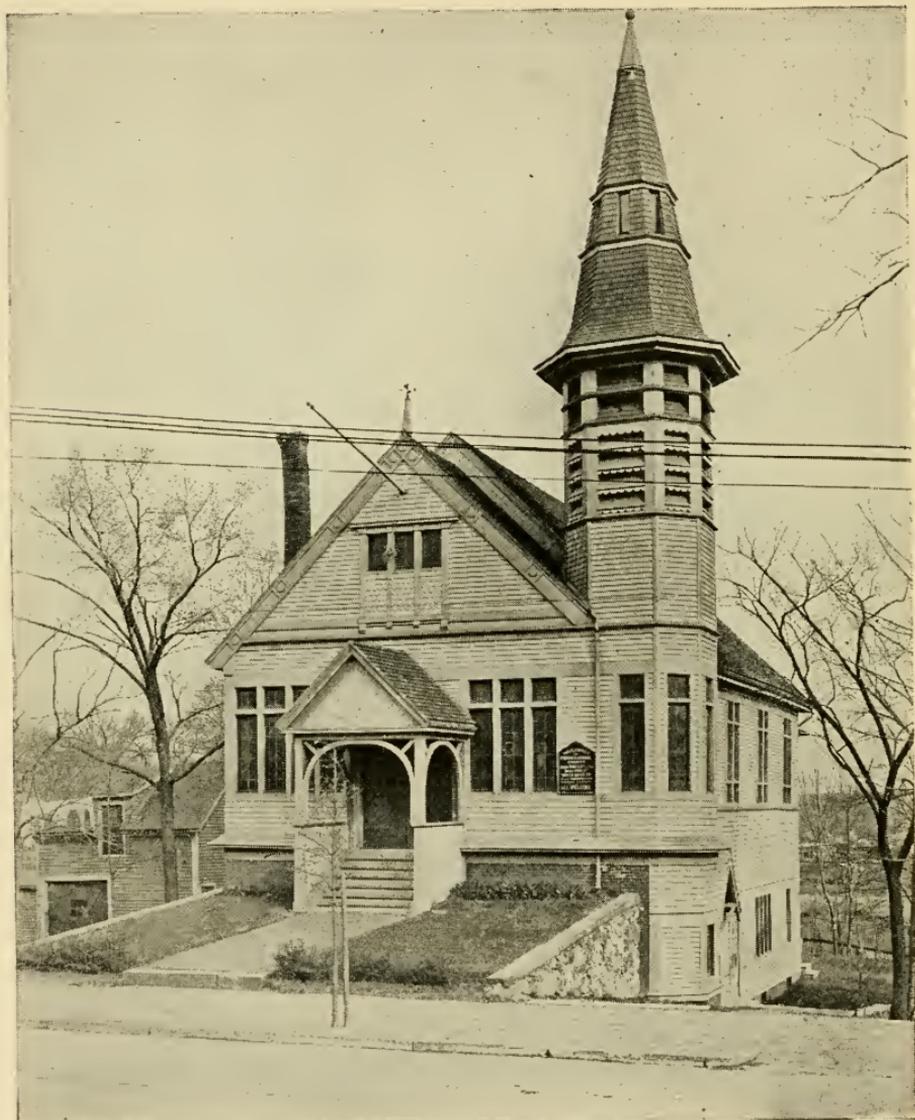
ILLUSTRATION 15. MAPLEWOOD CONGREGATIONAL CHURCH

This frame church is built on a site inadequate for any other purpose than the location of a building. The site is on such a steep slope that it prevents the use of any part of it or of nearby ground if acquired for any service. Landscape effects are almost impossible and the low, swampy land at the rear of the site prevents any expansion in that direction. The main elements in this situation are a church auditorium, rather severe but well maintained and a school assembly room about which there is little semblance of modernity. With limited equipment, a paucity of classrooms and almost no suitable service rooms, this plant can render only in slight degree the community service which might be possible.

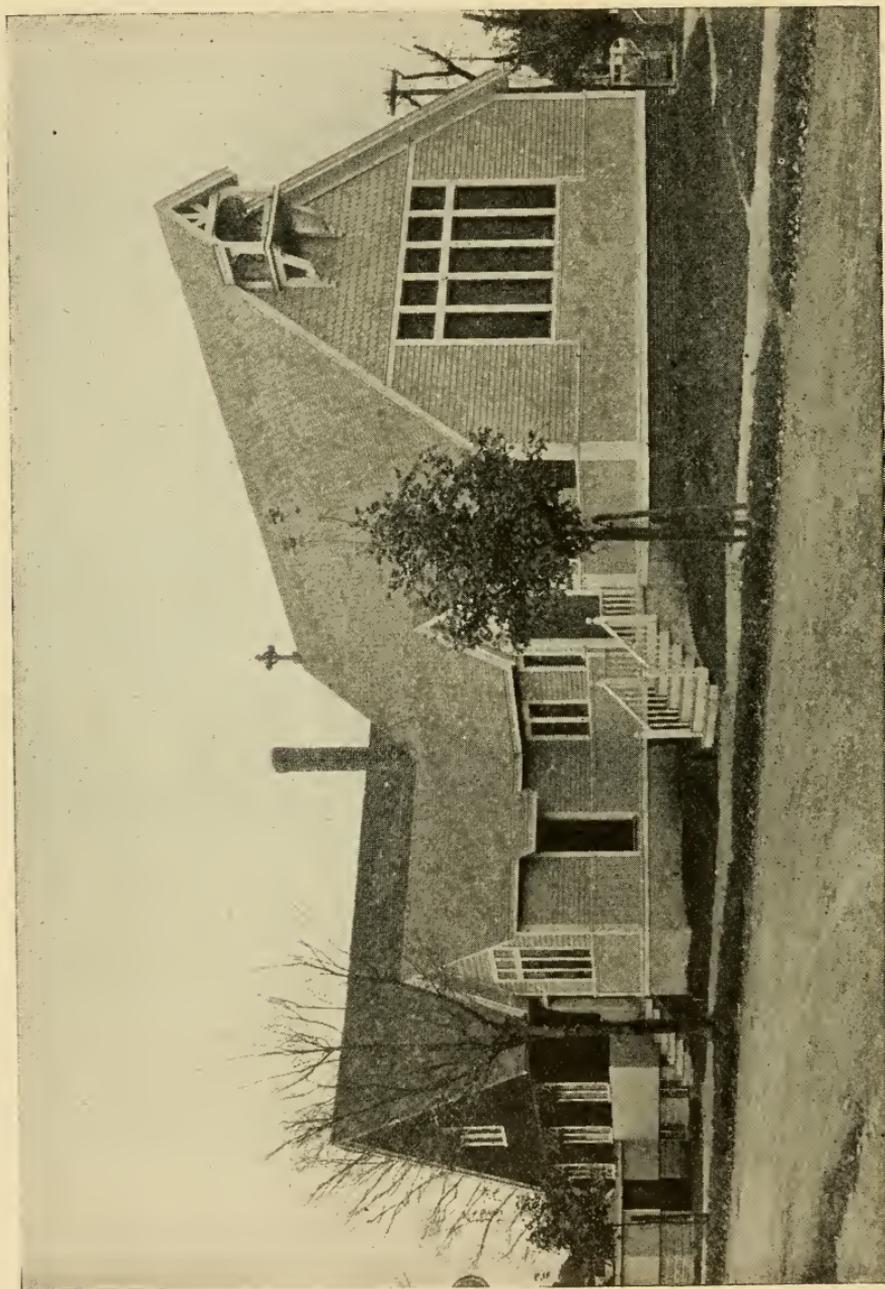
ILLUSTRATION 16. ST. LUKE'S EPISCOPAL CHURCH

Although this church is located in one of the less densely settled sections of Malden, its buildings cover a very large part of its site. The Linden section of Malden cannot adequately support three or four large community service church and religious education plants. The inadequate plants which exist there today are evidence of this fact. A cooperative community spirit should produce one large community house for this section. Such a plan need not interfere with differences in forms of worship but could assure religious education for the children and service for adults far beyond what has been found possible in the existing churches.

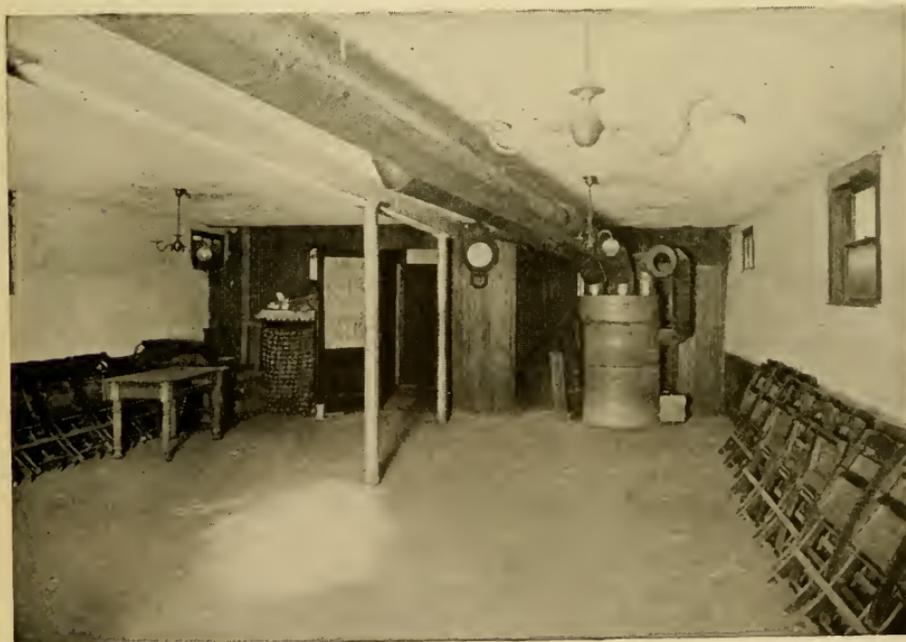
ILLUSTRATION 18. BASEMENT OF UNION BAPTIST CHURCH

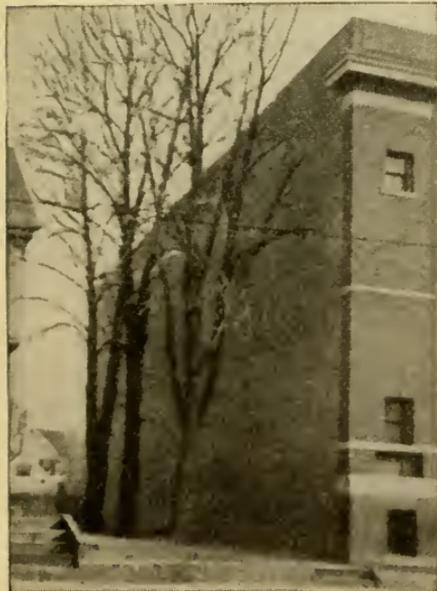
ILLUSTRATION 20. BLANK WALL OF PARISH HOUSE, FIRST BAPTIST CHURCH. THIS PREVENTS ADEQUATE LIGHTING OF LARGE ROOMS

Perhaps the most outstanding result of the effect of an inadequate site in a particular situation is that evident from study of illustration 22 and 20, pages 59 and 57. The religious school building of the First Baptist plant presents an attractive appearance from the church side. The site, however, is so small that it was considered necessary to build this structure with one side close to the neighboring property line. The building, on this side, has been given a blank wall, thereby detracting to a considerable degree from its beauty both within and without and from the advantages that accrue from good natural lighting of classrooms. A school building of this size requires a site sufficiently large for play and pageantry purposes.
